Oldland Mill, Keymer, Sussex.

Report on Condition, and Suggestions for Repair 12th July 1980.

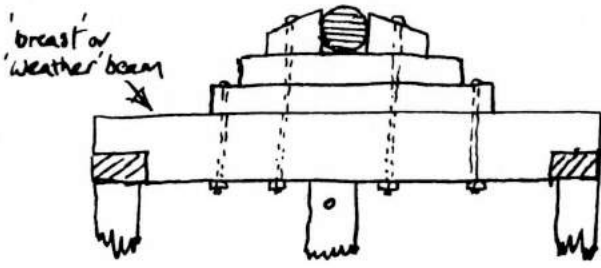
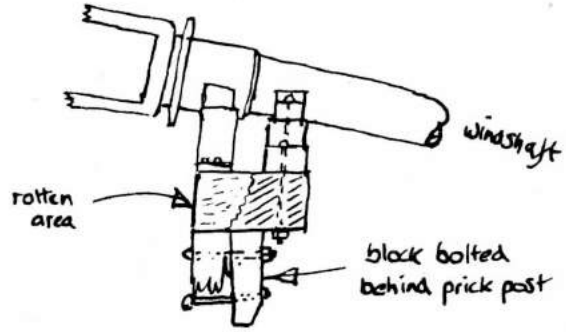
Sketches 1 & 2 - Temporary support for windshaft:

1) The weather- or breast beam which carries the windshaft and sweeps is very rotten, and the cast-iron chair which bears the neck brass is sinking in and tilting to the left. If this is not dealt with soon, the windshaft and sweeps may overbalance and crash down through the Mill, causing severe damage and collapse. It is suggested that a spreading beam is bolted down to the weather beam behind the neck bearing to spread the weight, and a dummy wooden bearing bolted to it to carry the windshaft, but allowing the rotation of the sweeps during their removal. In addition, a block of wood should be bolted to the prick-post to support the back of the weather beam which will now be taking some of the weight. See sketches 1 and 2.

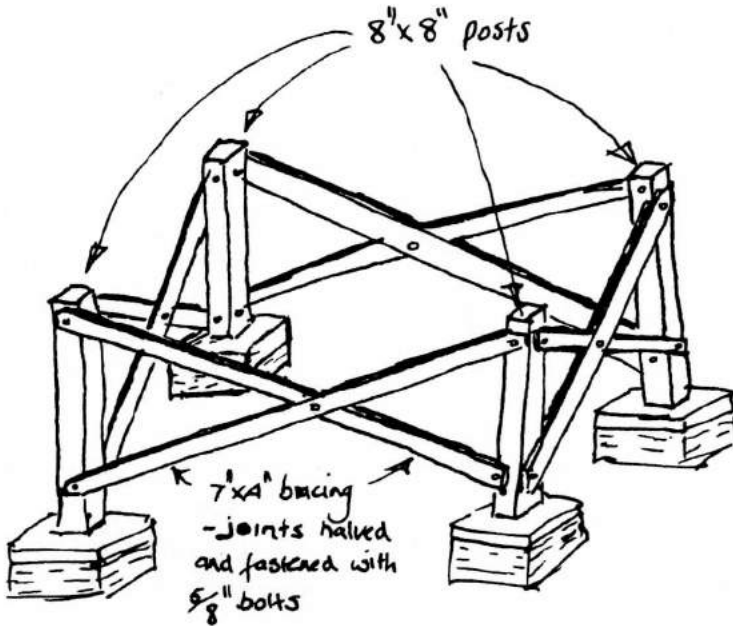
Sketch 3 - Timber shoring under main corner posts

2) As pointed out by yourselves, the existing shoring under the Mill is unsafe and over-complicated, and does not offer much protection against the Mill being blown over.

Whilst steel shoring has been suggested, my own preference is for wooden shoring, which looks much less ugly than steel, and is easier to modify and adapt on site with normal tools. In addition it is easier to attach a flashing where a post or brace passes through the roundhouse roof. I would suggest four props, one under each of the four main corner posts as before, but cross-braced to withstand wind pressure. The bracing will have to be placed where space permits, avoiding the trestle timbers. See sketch 3.

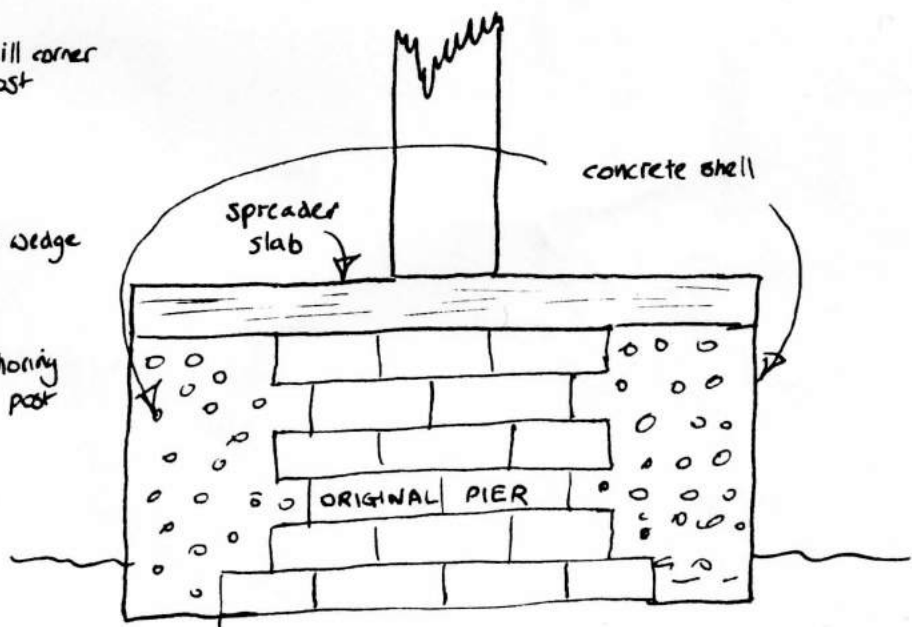
Sketch 5 - Detail of shoring post pier.

The original posts have rotted inside their brick casings. The piers supporting them are rather small, and could be increased in size by casting concrete shells around them. The new posts should be footed on 4" thick timber slabs on top of the piers to spread the weight. See sketch 5.

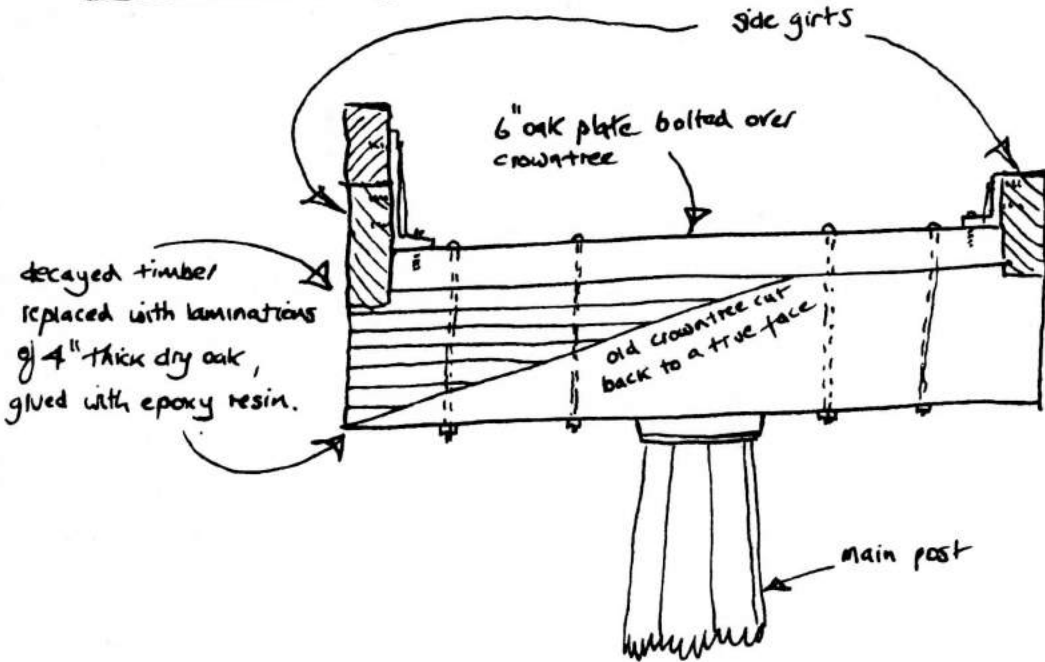
Sketch 6 - Suggested Repair to Crowtree

The crowntree is very badly worm-eaten on the left-hand side from the joint with the sidegirt almost to the centre. It has moved approx. 4" upwards in relation to the left sidegirt. I think the best way to deal with this is to cut away the beam by chainsawing, cross-cutting and splitting off, electric planing etc. back to an inclined true face, and to shape new timber to fit. This may be in the form of laminations glued with epoxy resin to avoid handling a large heavy timber. A 6" thick oak plate should be installed above, and the whole assembly bolted together. See sketch 6.

In order to do this, the millstones and some of the floor will have to be removed. The stones could be lowered to the first floor while this work is in progress. A simpler alternative, though not so strong, would be to just install the 6" oak plate, bolted over the crowntree, and fastened to the sidegirts with the existing brackets.

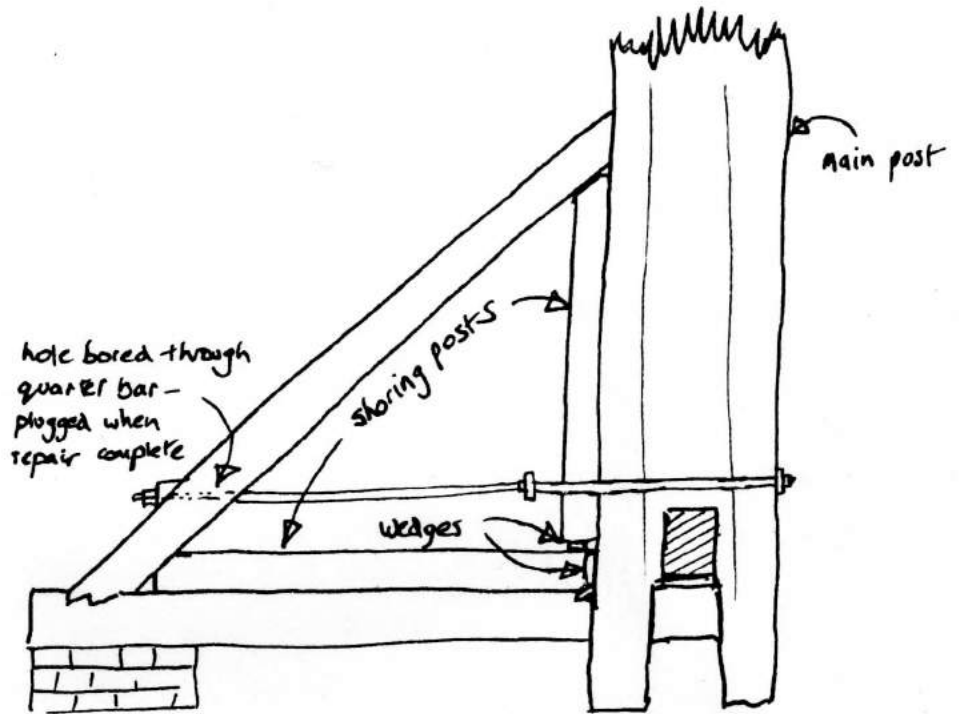
Sketch 7 - Suggested Method of securing trestle joints while under repair.

The post is worm-eaten to some extent, but appears to be sound enough. The lower crosstree is of pine, and one end is missing, the quarter bar bearing on packing on the brick pier, and the roundhouse wall. Two tie-rods from the post are provided to take the tension, but are poorly fastened to the post and not reliable. The other quarter bar joint is covered with felt weather protection and hidden thereby, but it is assumed to be badly rotten.

The upper crosstree is of oak, but the end near the door is badly worm-eaten, and hollow half way from the quarter bar joint to the post. Both quarter bar joints are assumed to be in bad condition, but are hidden from view as above.

As far as repair is concerned, the ideal solution would be to renew the crosstrees and quarter bars as was done at Nutley Mill by volunteers. An alternative would be to add "cheek pieces" to the crosstree-quarter bar joints, as suggested by Mr. Gregory. Where these already exist, but are in poor condition, it would be necessary to remove the originals first. Extra temporary reinforcement would be essential when this was being done. See sketch 7.
