## Old Mill, Cassiobury

The Old Mill, Cassiobury Park, Watford -  
Community Archaeology  
Aug./ Sept. 2016

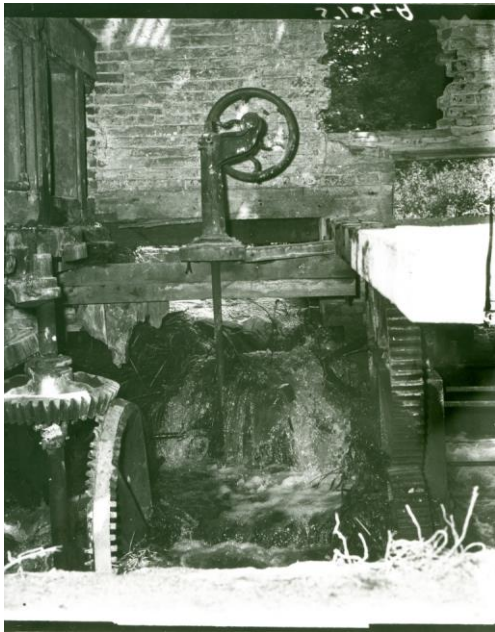
They show the position of a 310mm x 21mm beam, which spanned across the river bed. Do you think it is a reasonable assumption that this was the base timber of the hurst frame and might have carried one end the axle of the waterwheel? The hursting is visible, on the left of the b&w photo.

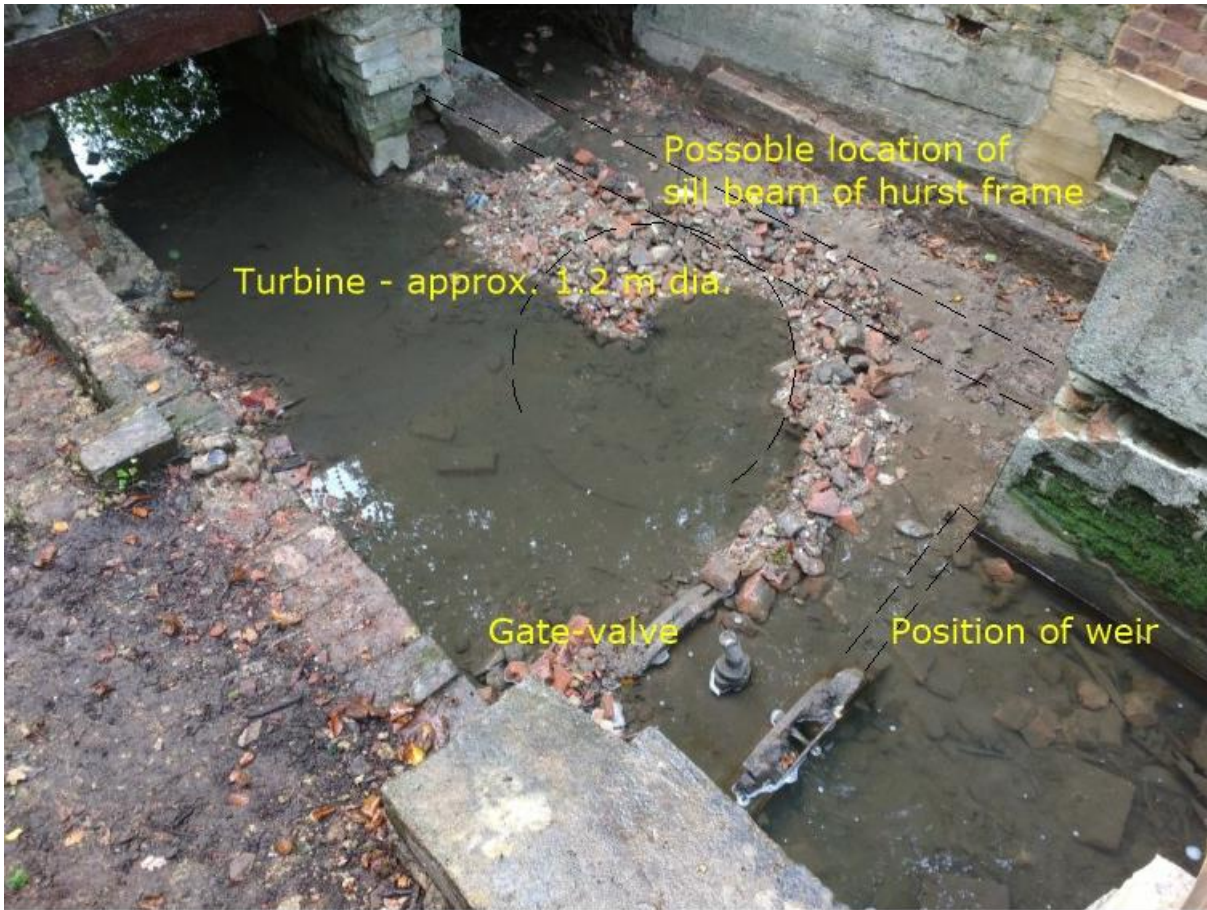
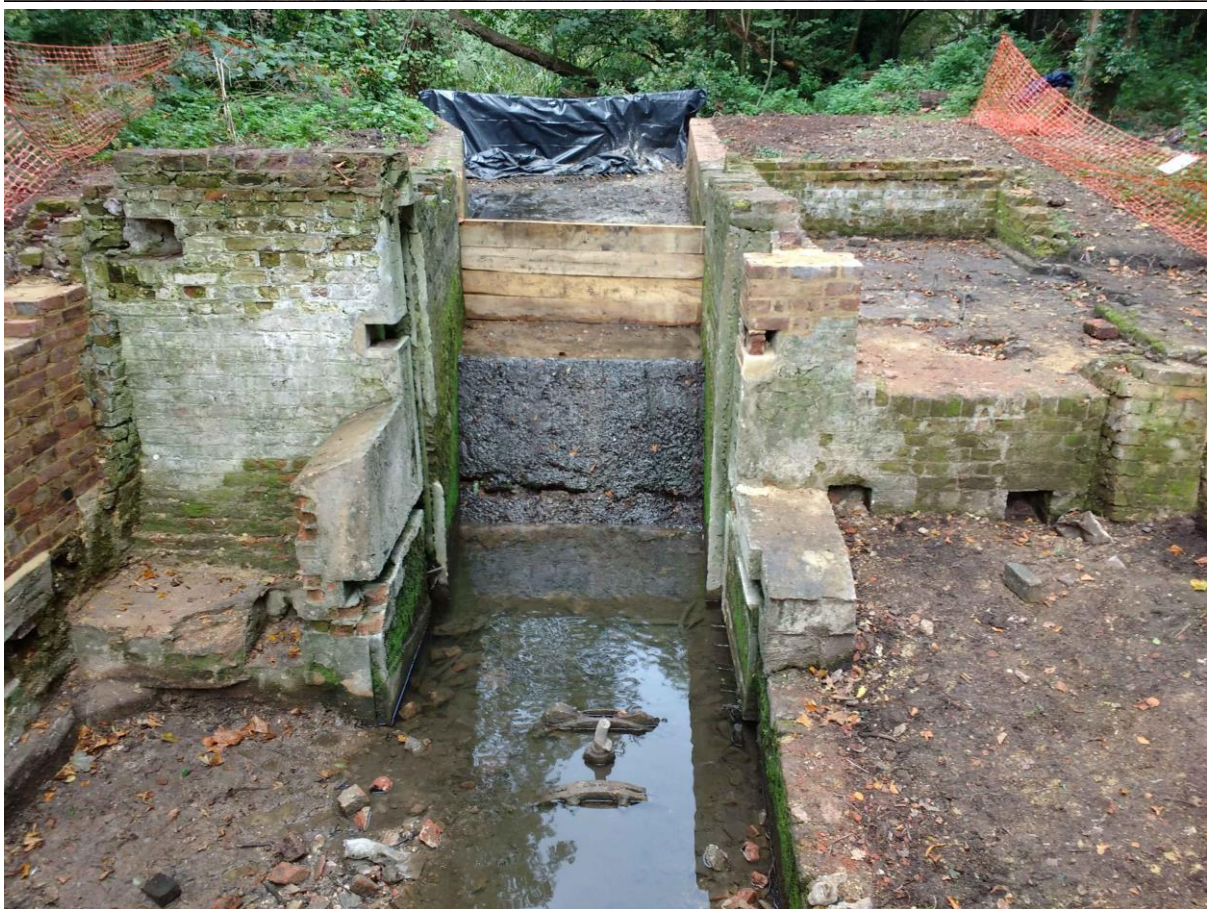
The plan and recent photo also show a large gate-valve and a circular metal object, buried in the base of the river. This must be the turbine installation, for which there is written evidence. In the 1922 it was driving a set of three throw horizontal pumps; these pumped water from a nearby spring up to Cassiobury House.
